**U.S. 101 MP 100.70 Unnamed Tributary (WDFW ID 990730):
Preliminary Hydraulic Design Report**

U.S. 101 MP 100.70 Unnamed Tributary
Preliminary Hydraulic Design Report
[January 2022](#)

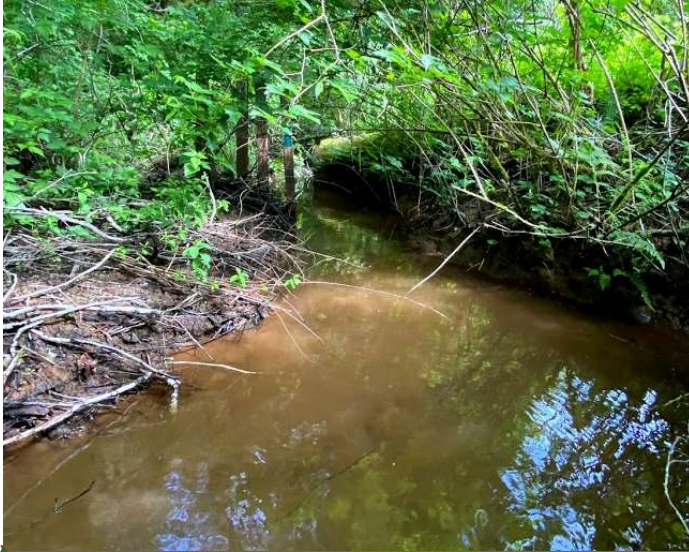
Figure 4: Looking downstream at roadway posts on the left bank above the culvert inlet

Moved up [6]: 4). Downstream of the roadway posts, the channel takes a hard 90-degree right turn to enter the culvert. The culvert inlet projects from the roadway fill with a 4-5 feet long section broken off (Figure 5). The culvert outlet projects from the road fill and has a clean bottom (Figure 6). The channel takes a 90-degree turn below the outlet and appears to have been excavated into hardpan for conveyance back to where the historic channel leaves the road (Figure 7).¶

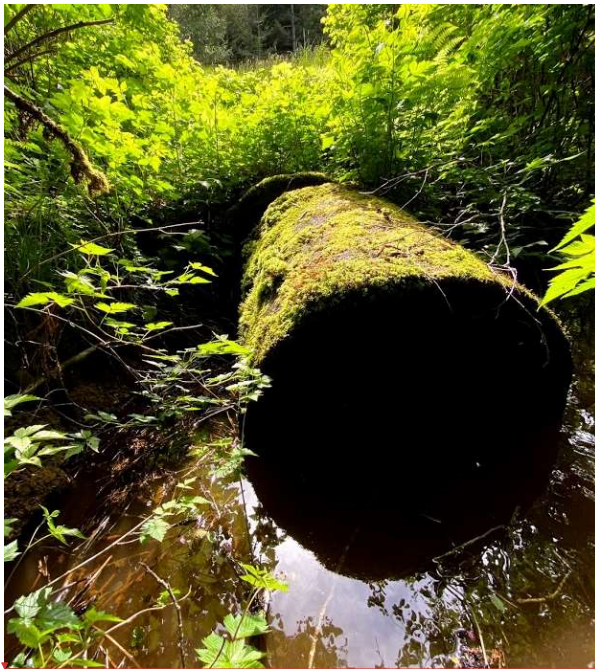
Figure 5: Culvert inlet with broken segment

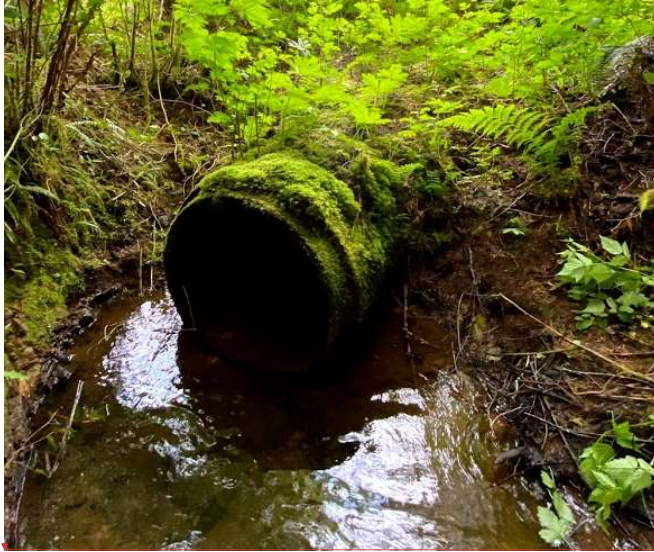
Figure 6: Culvert outlet

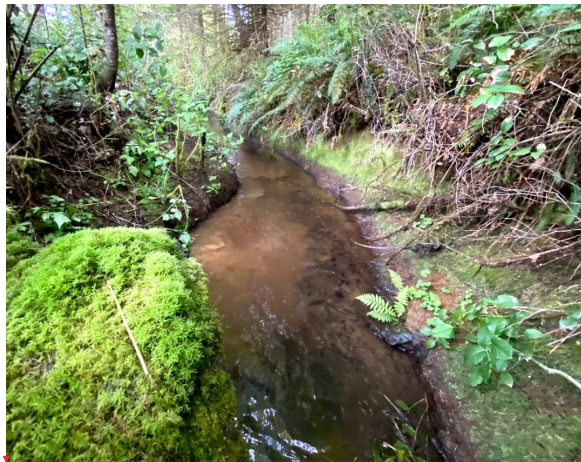
Figure 7: Looking downstream of the culvert outlet

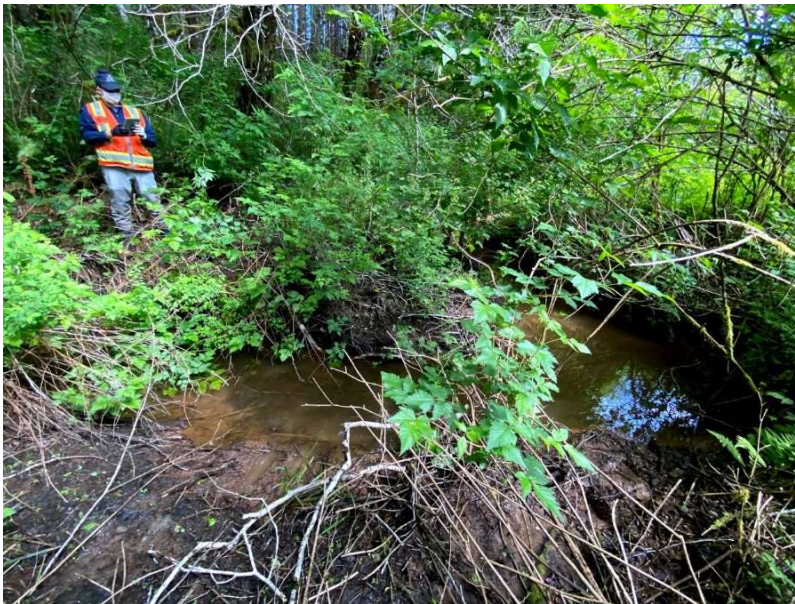
Figure 8: Example of small woody material in channel

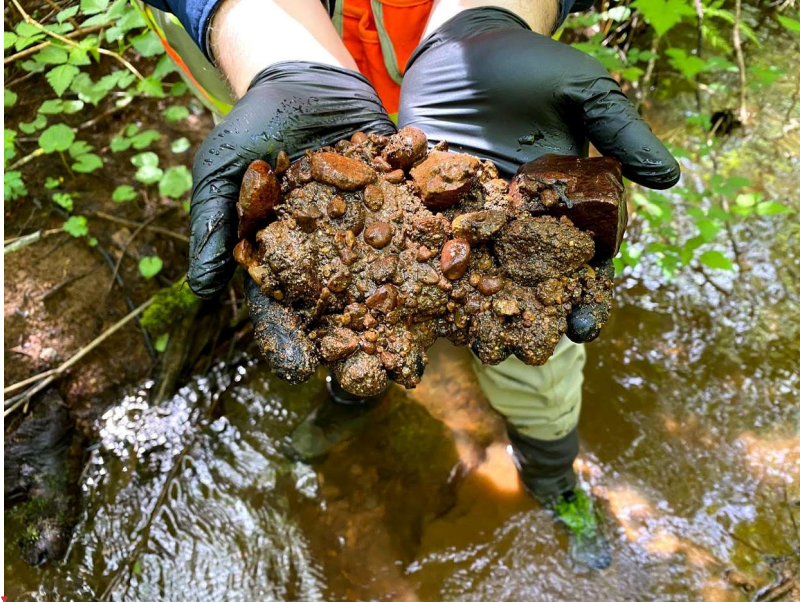
Figure 9: Representative gravel streambed material upstream of culvert

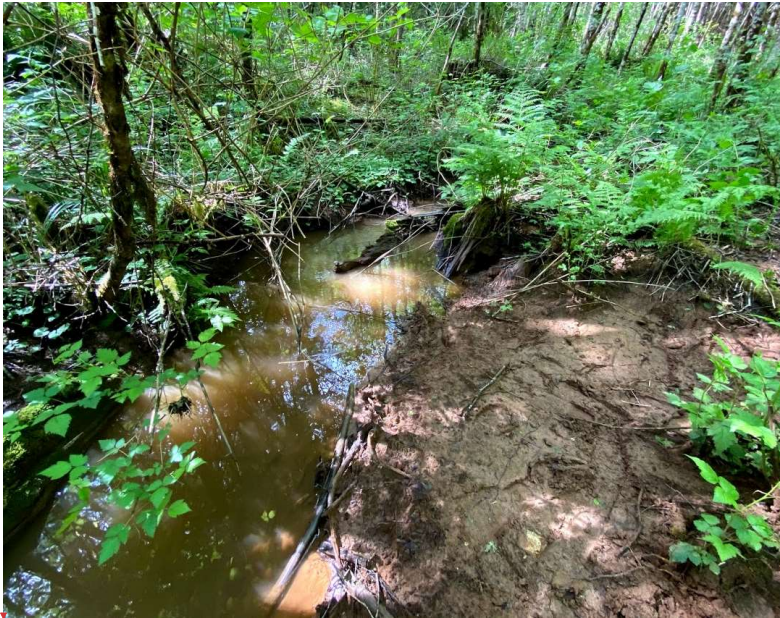
Figure 10: Example of erodible banks and large fines deposits along channel upstream of culvert

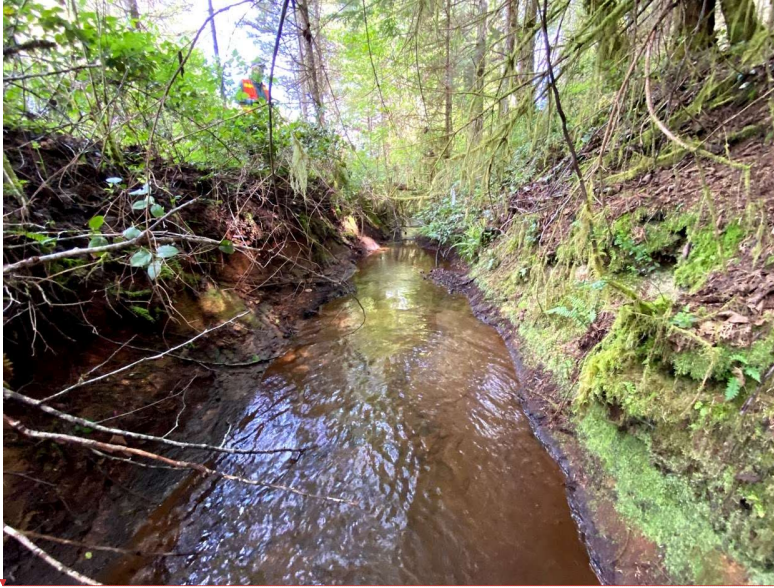
Figure 11: Typical excavated channel section downstream of culvert outlet

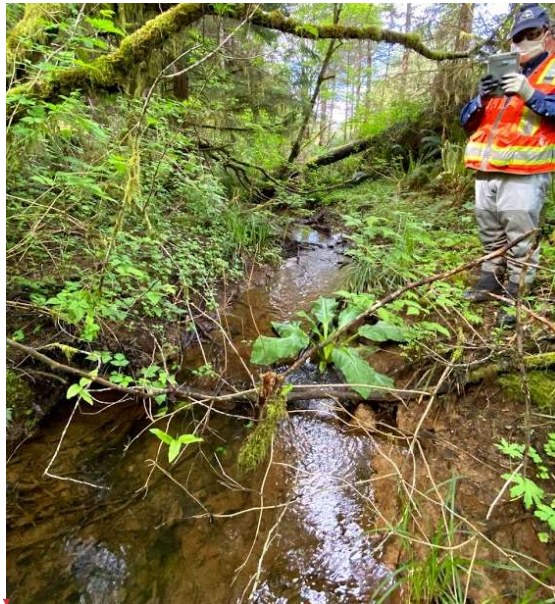
Figure 12: Representative view of unconfined channel downstream of the culvert

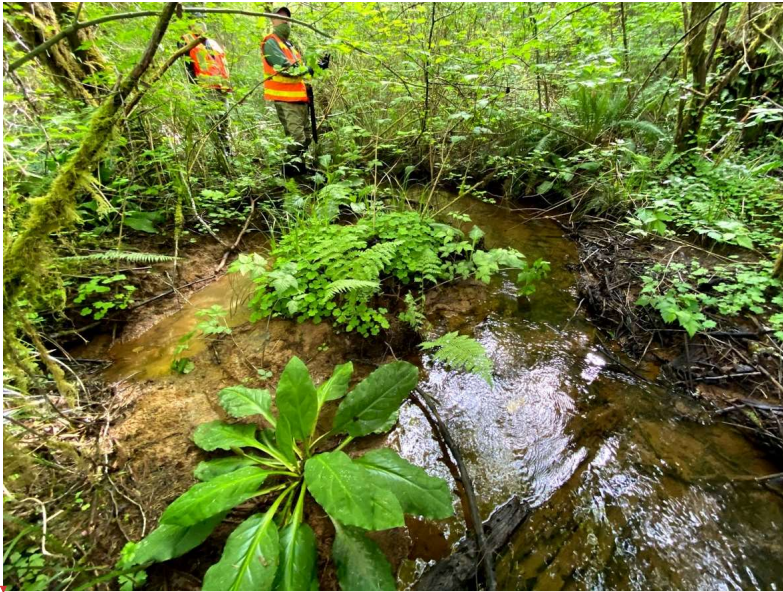
Figure 14: Flow split within the unconfined section downstream of the culvert

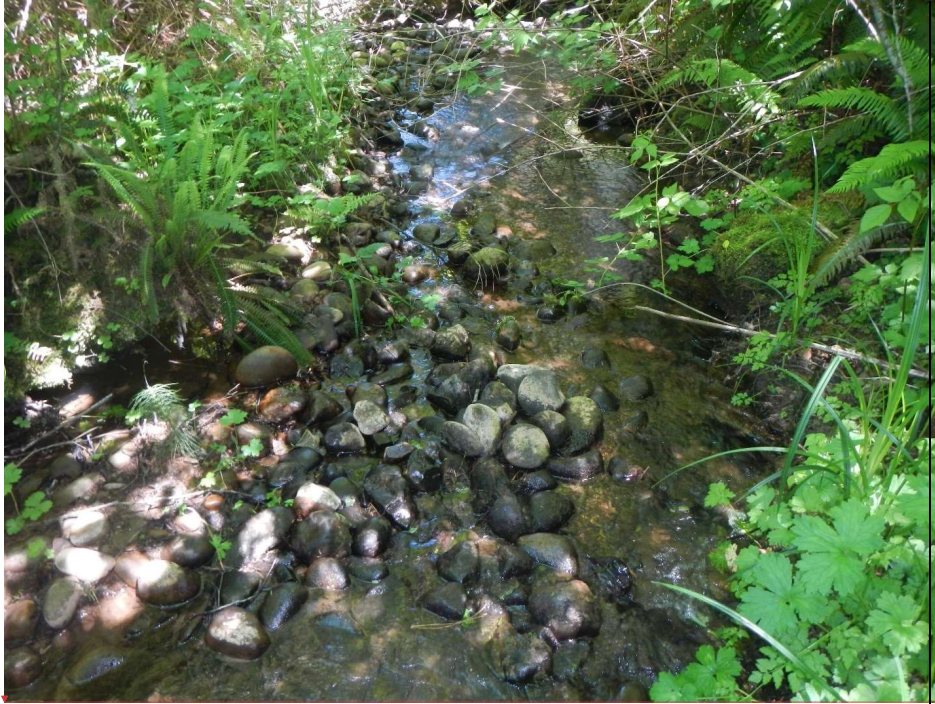
Figure 17: Cobble grade control downstream of unconfined reach below culvert

The downstream reach can be characterized as three sequential sub-reaches with different channel types. The excavated section below the culvert is highly confined with steep walls as it runs parallel to U.S. 101 for approximately 125 feet. There is little habitat complexity in this subreach. The banks and channel within this section are both hardpan material. The channel is fairly shallow, around 0.5 foot deep. Stream bank height varies from 4 to 7 feet (Figure 11). The channel meanders away from the road prism between two older Douglas Fir (*Pseudotsuga menziesii*) trees and the floodplain opens up with large patches of wetlands vegetation. The two older trees appear to bracket where the historic channel planform ran under the present highway's footprint. The channel is less confined, with more woody material, small step pools, flow splits, and logs and rootwads (Figures 12-15). Substrates include gravel downstream of steps, and extensive deposits of sand and small gravel (Figure 16). Farther downstream where the channel abuts Larson Brothers Road, there is a distinct cobble bedded grade control (Figure 17).

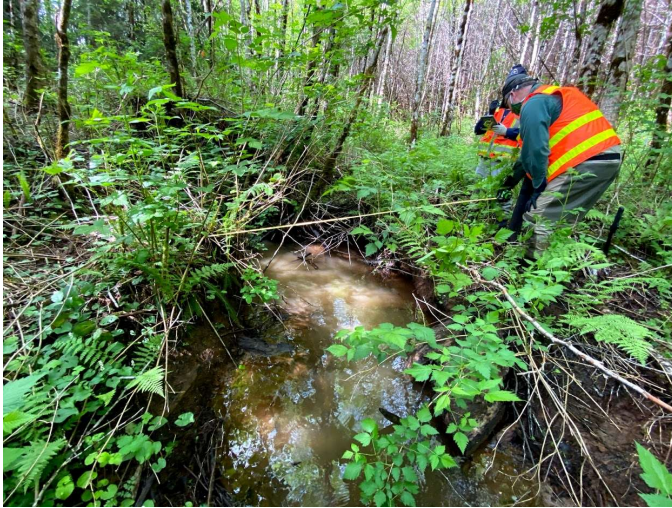
Figure 18: Example of low profile floodplain and bankfull channel upstream of culvert

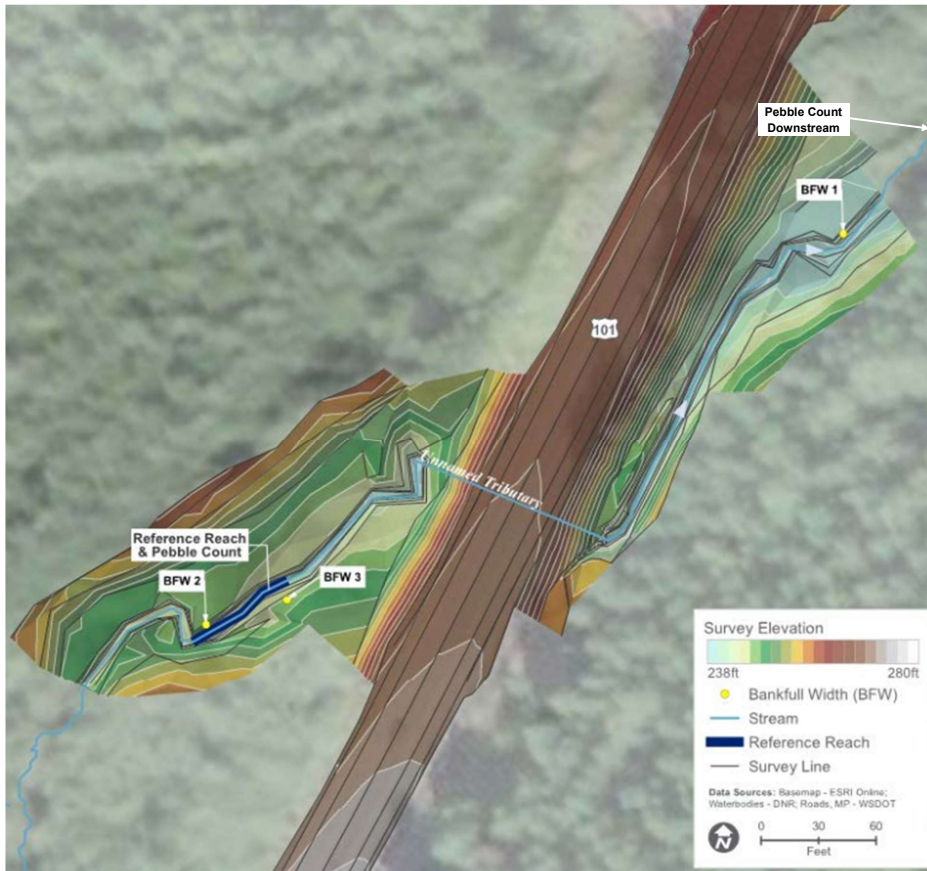
Figure 19: Reference reach and locations of BFW measurements and substrate sampling

A reach starting approximately 130 feet upstream of the culvert (Figure 19) was selected as most representative of the natural stream channel with the least anthropogenic influence, and is situated in line with the larger scale reach grade (see Section 2.8.4). The reference reach was relied on primarily for measuring bankfull dimensions for informing the design of the hydraulic opening width and the cross-section morphology of the constructed channel outside of the replacement structure footprint. The reference reach morphology was not used to design cross-section shape and planform underneath the replacement structure because vegetation controlling bank stability cannot generally grow there.

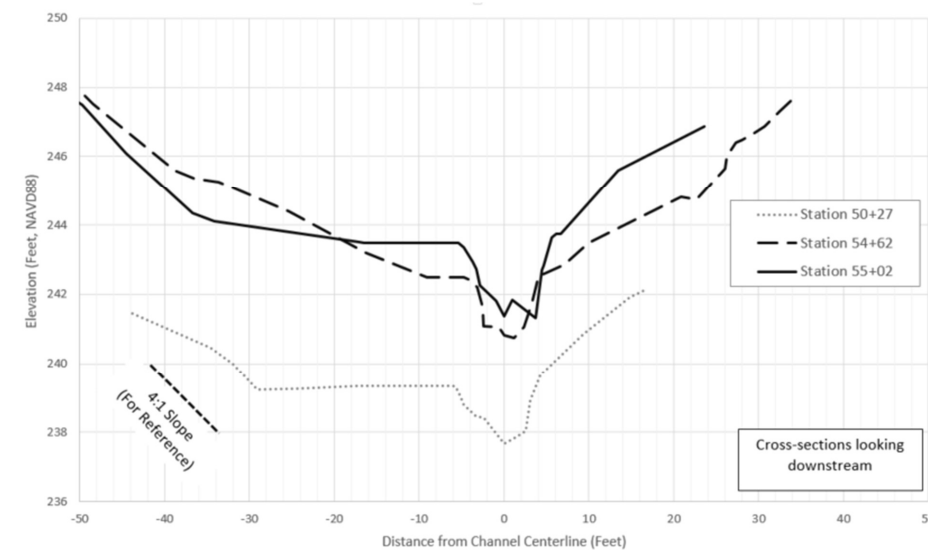
Figure 23: WSDOT's surveyed cross-section profiles upstream of the culvert

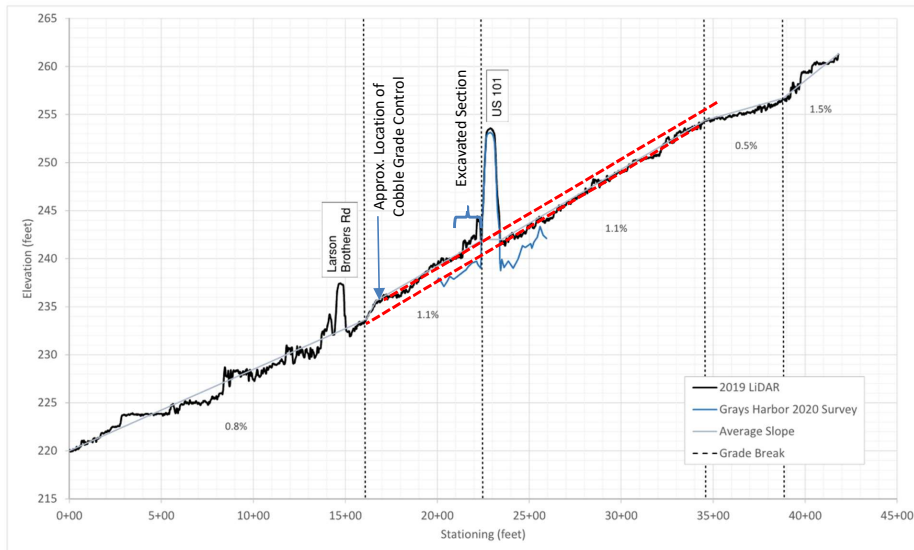
Figure 24: Watershed-scale longitudinal profile (NAVD88 datum); Red dashed lines indicate approximately parallel reach scale grades upstream and downstream of US 101 that were offset by construction of the existing culvert

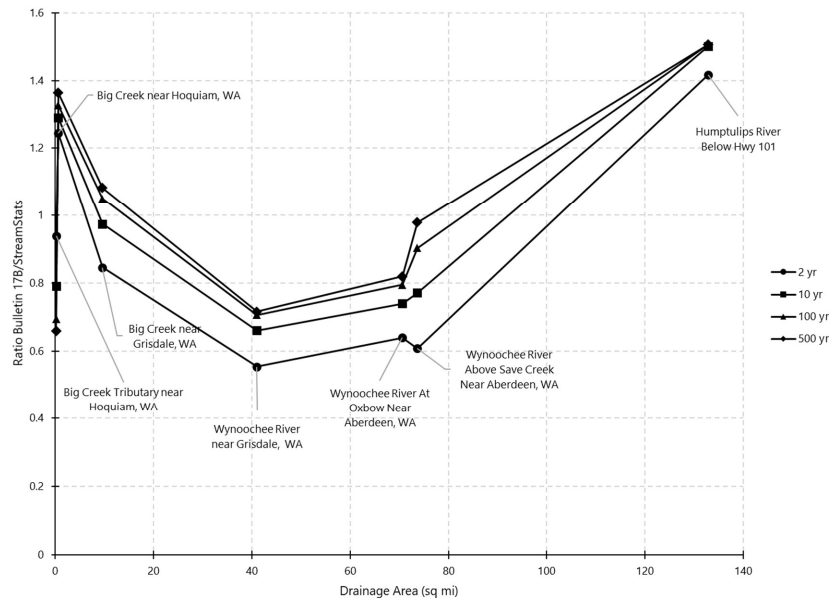
Figure 25: Ratio of gage-based flood peak magnitudes vs. regression-based estimates, plotted against drainage area

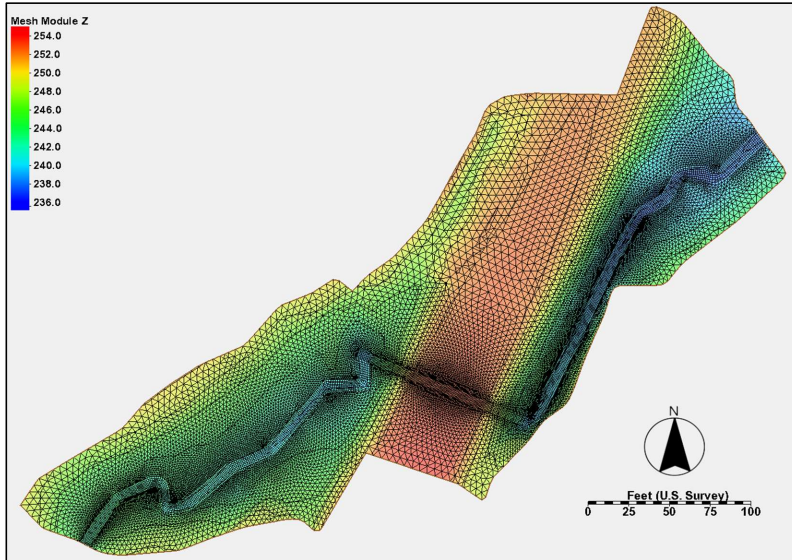
Figure 26: Existing-conditions computational mesh with underlying terrain

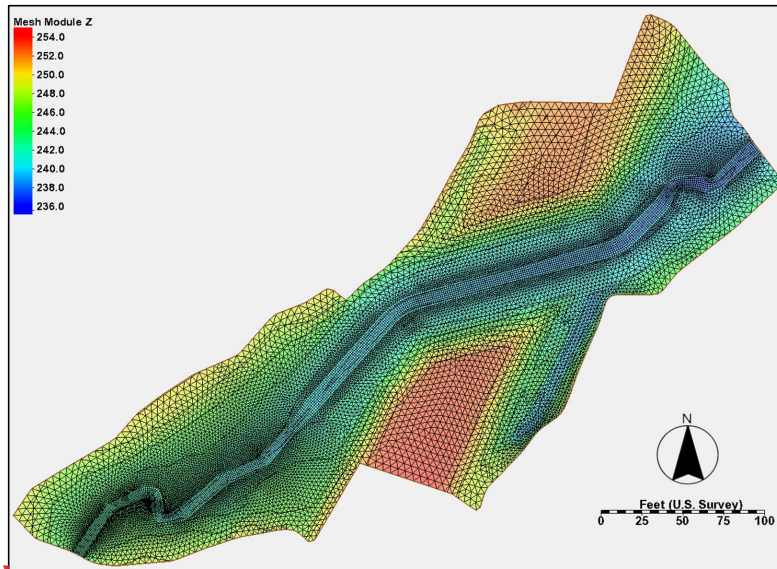
Figure 27: Natural-conditions computational mesh with underlying terrain

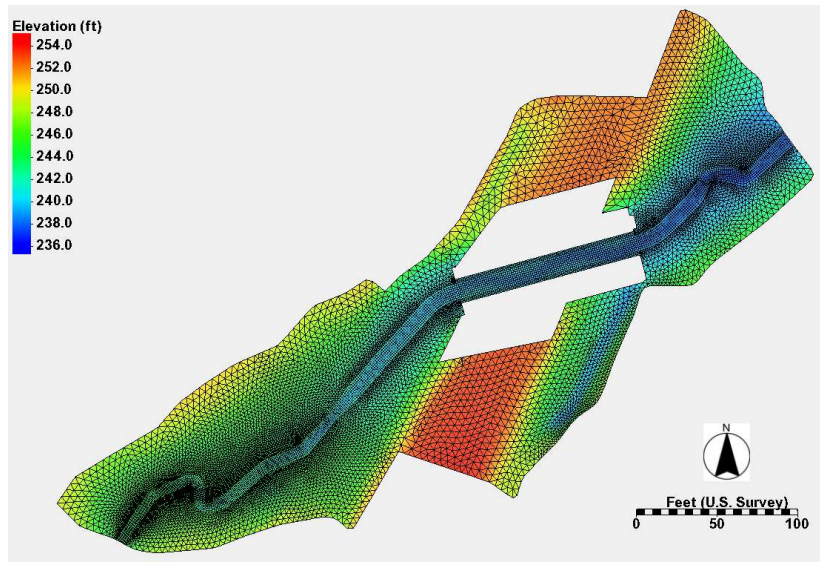
Figure 28: Proposed-conditions computational mesh with underlying terrain

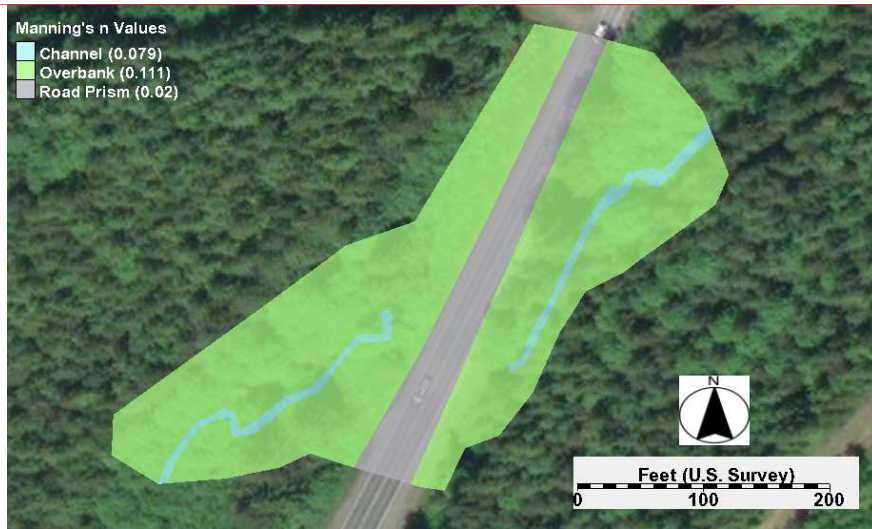
Figure 29: Spatial distribution of roughness values in SRH-2D existing-conditions model

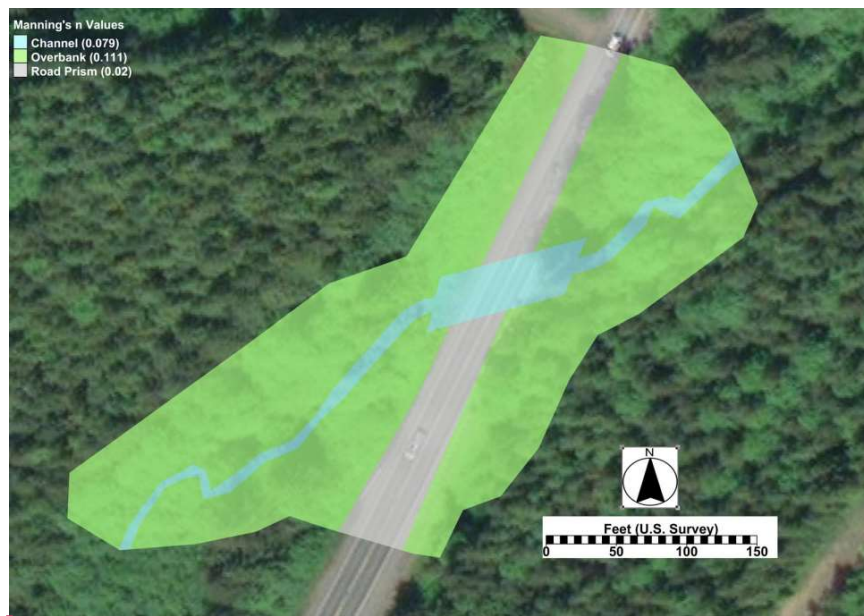
Figure 30: Spatial distribution of roughness values in SRH-2D natural-conditions models

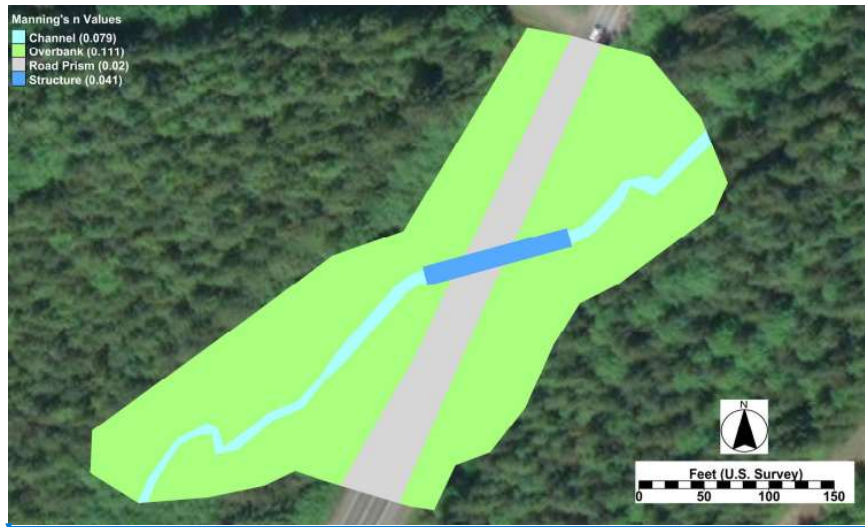
Figure 31: Spatial distribution of roughness values in SRH-2D proposed-conditions models

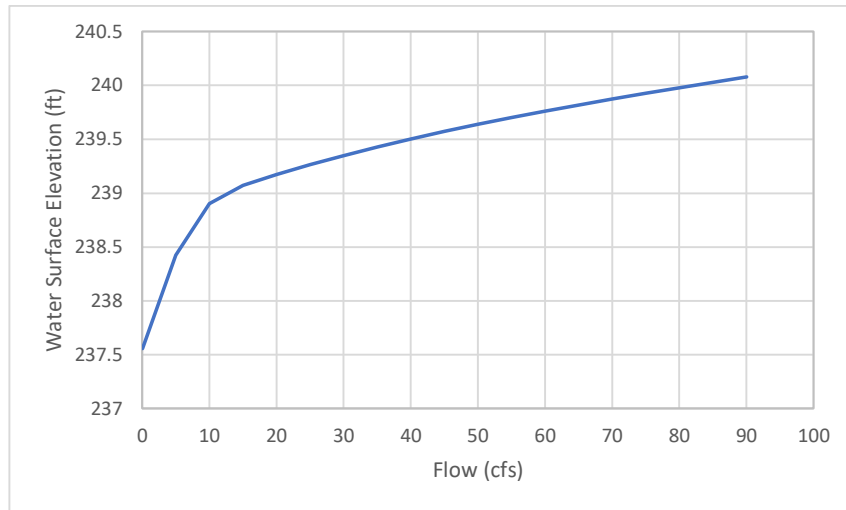
Figure 32: Downstream normal depth rating curve

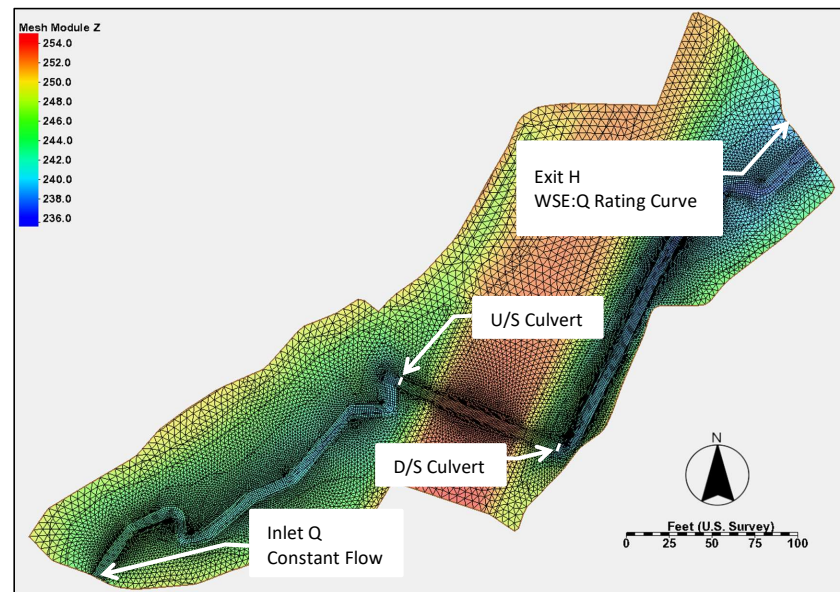
Figure 33: Location of boundary conditions for the existing-conditions model

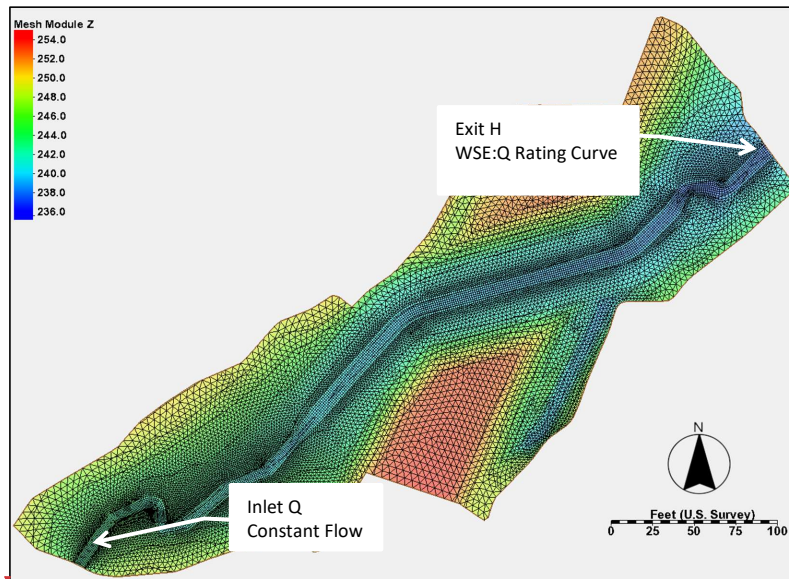
Figure 34: Location of boundary conditions for the natural-conditions model

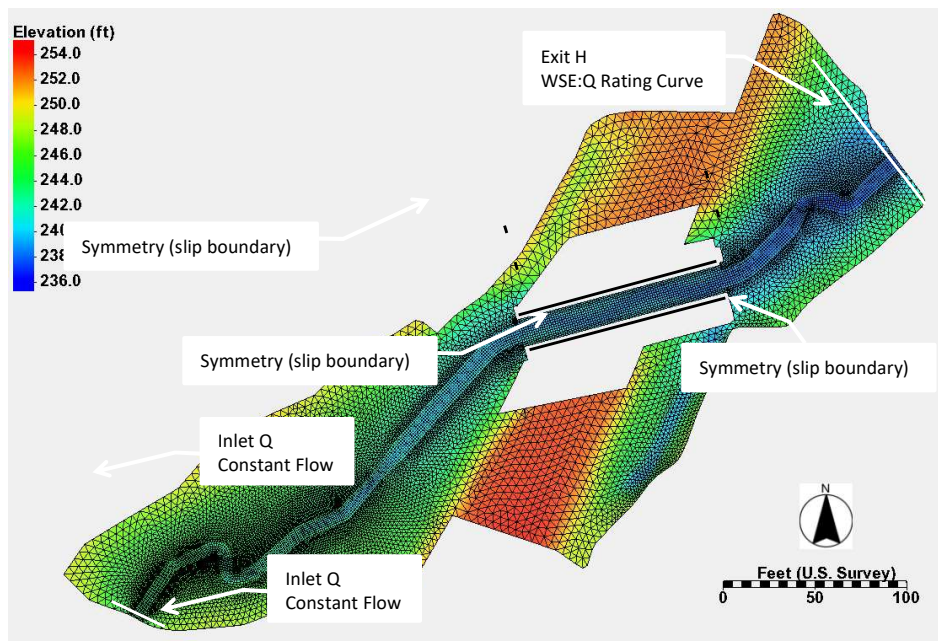
Figure 35: Location of boundary conditions for the proposed-conditions model

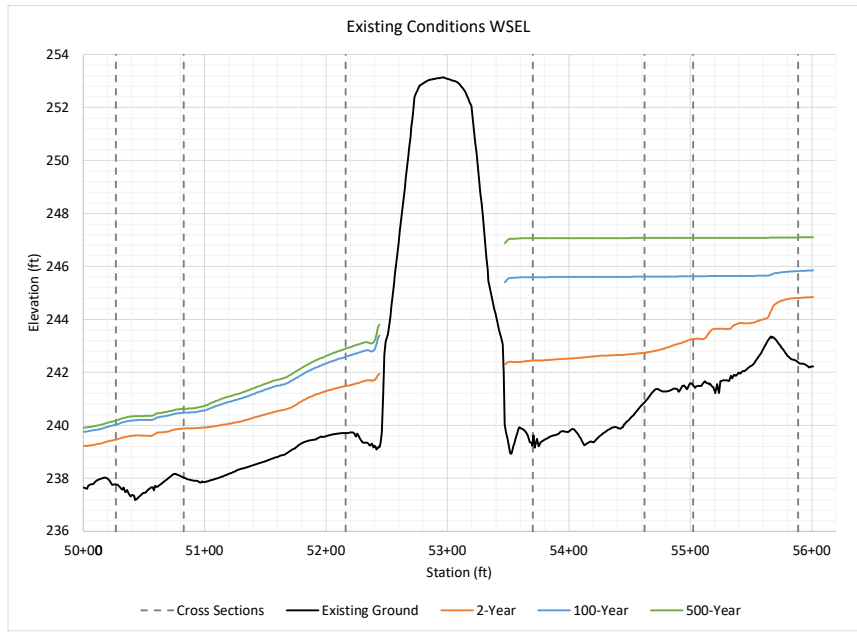
Figure 40: Existing-conditions water surface profiles

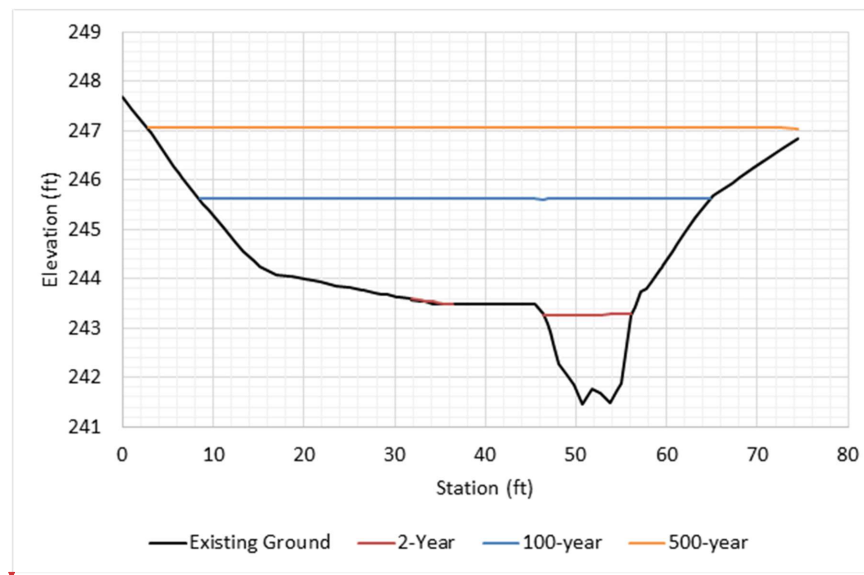
Figure 41: Typical upstream existing channel cross section

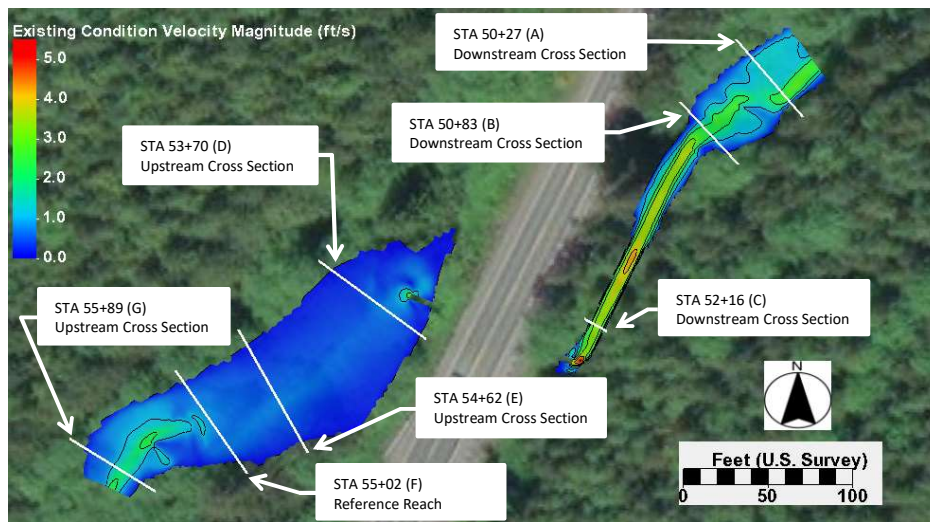
Figure 42: Existing-conditions 100-year velocity map with cross-section locations

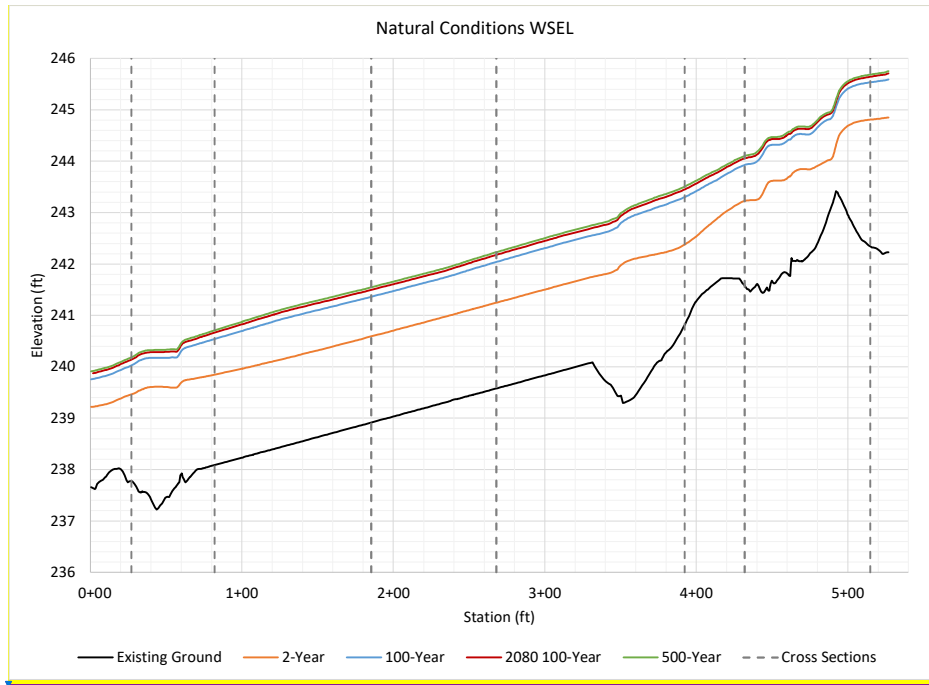
Figure 45: Natural-conditions water surface profiles

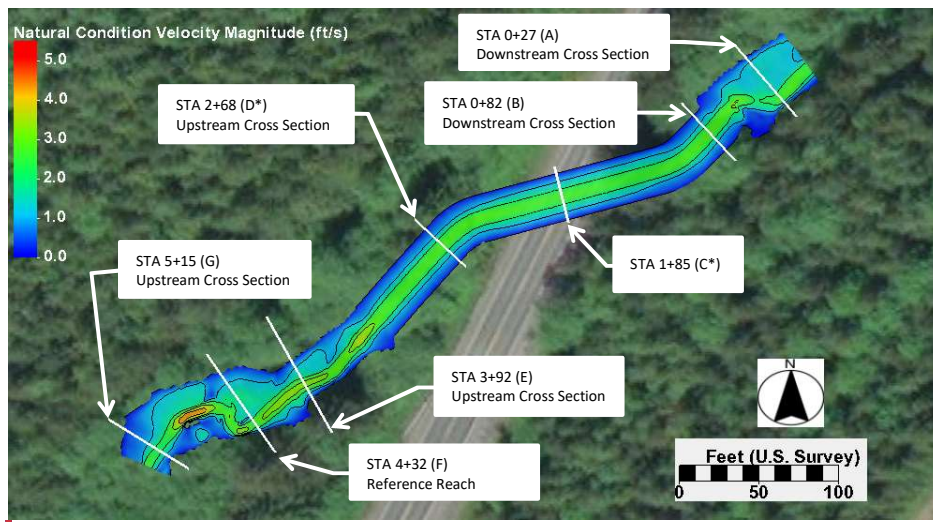
Figure 47: Natural-conditions 100-year velocity map with cross-section locations

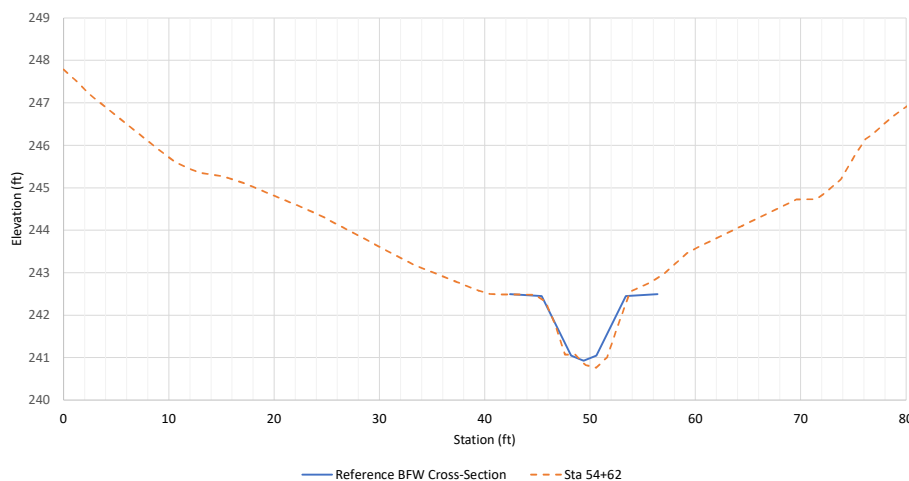
Figure 49: Comparison of design cross-section with a representative cross-section outside of the replacement structure footprint

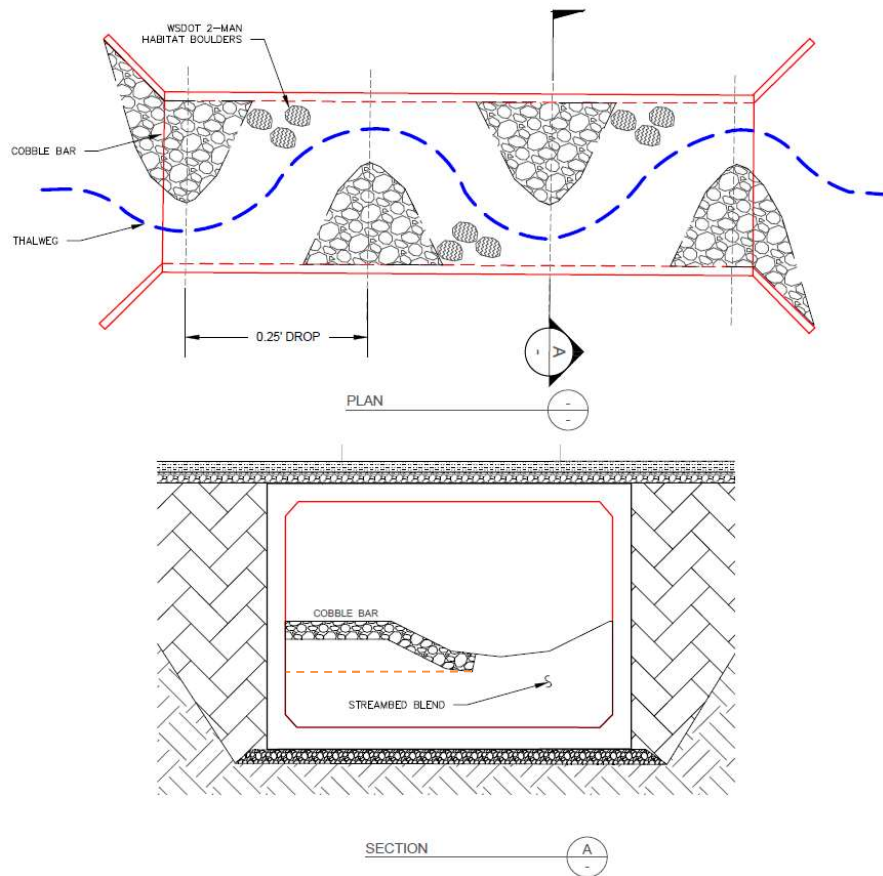
Figure 50: Schematic of proposed channel planform (top) and cross-section (bottom) layout inside the culvert. If there is concern of future loss of bar material to downstream, the thickness of the cobble layer can be increased to the dashed line.

The corresponding proposed design is depicted schematically in Figure 50.

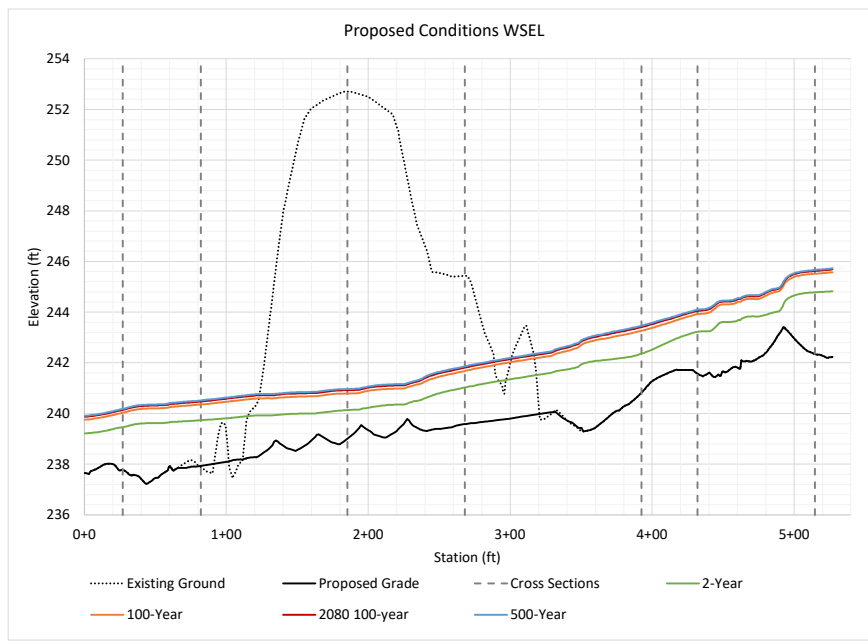
Figure 52: Proposed-conditions water surface profiles

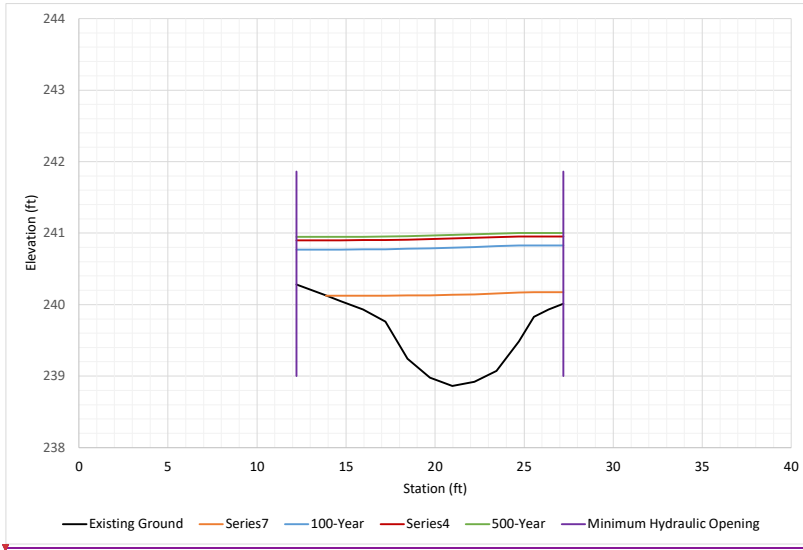
Figure 53: Typical section through proposed structure (STA 1+85)

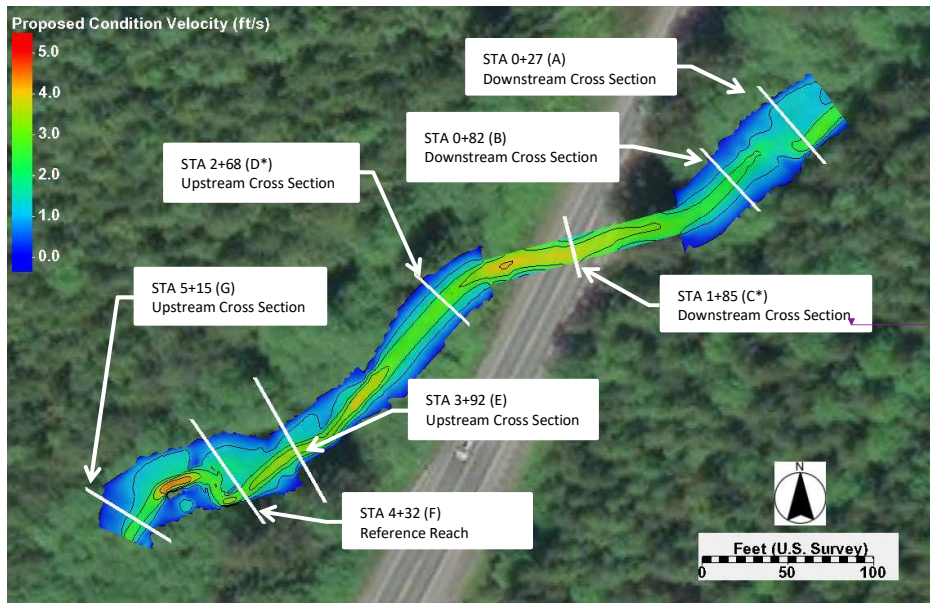
Figure 54: Proposed-conditions 100-year velocity map

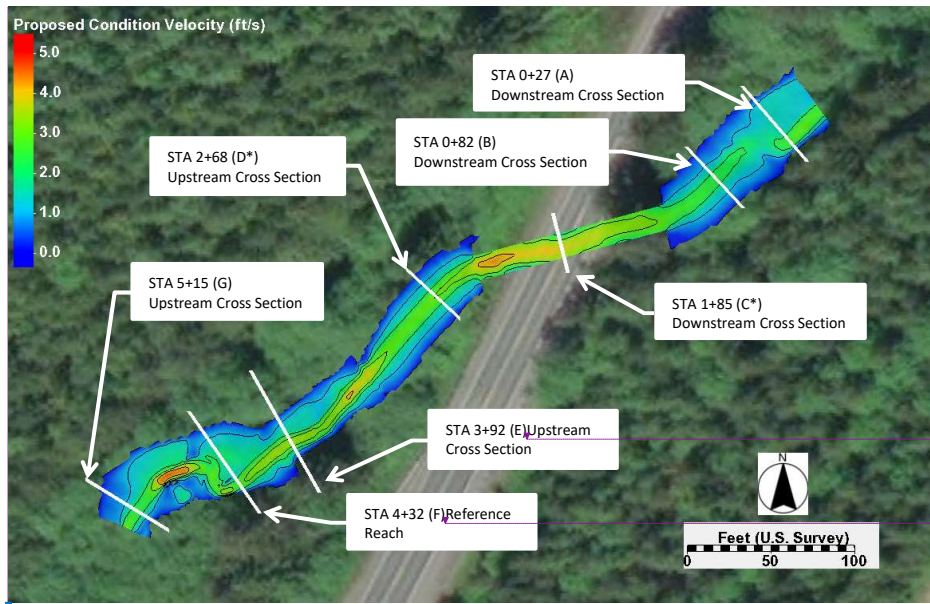
Figure 55: Proposed-conditions 2080 predicted 100-year velocity map

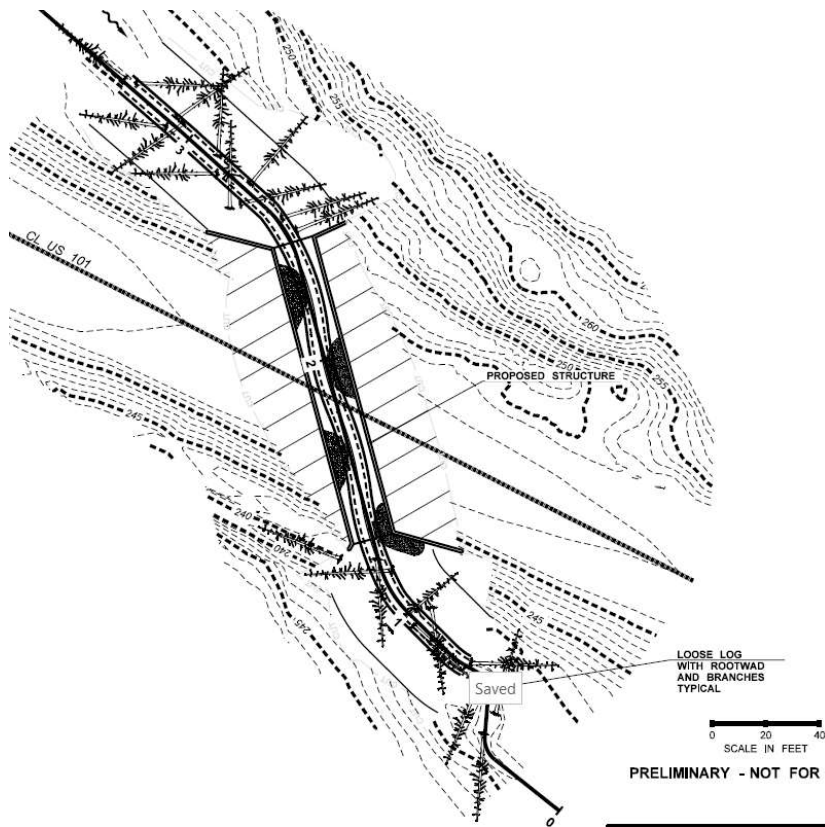
Figure 57: Conceptual layout of key LWM and alternating bars for habitat complexity

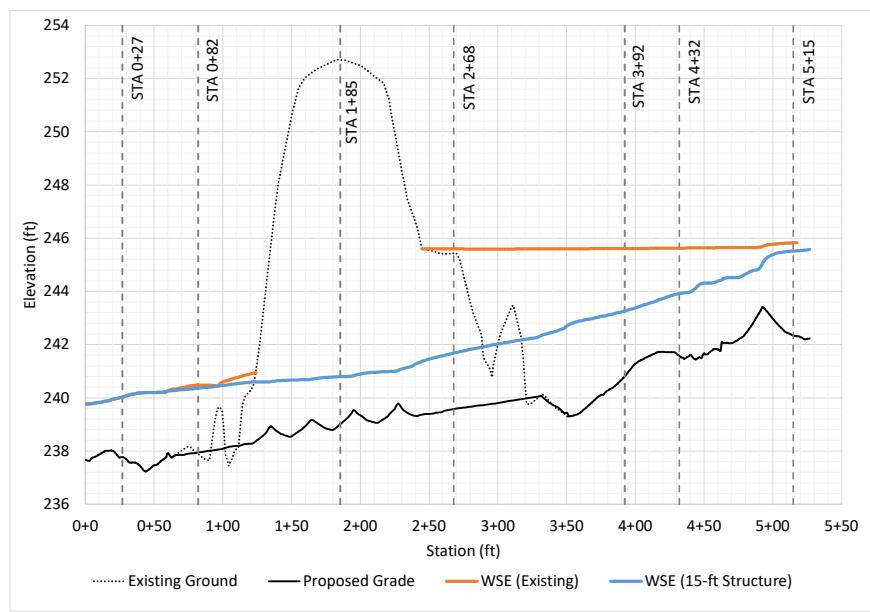
Figure 58. Existing- and proposed-conditions 100-year water surface profile comparison

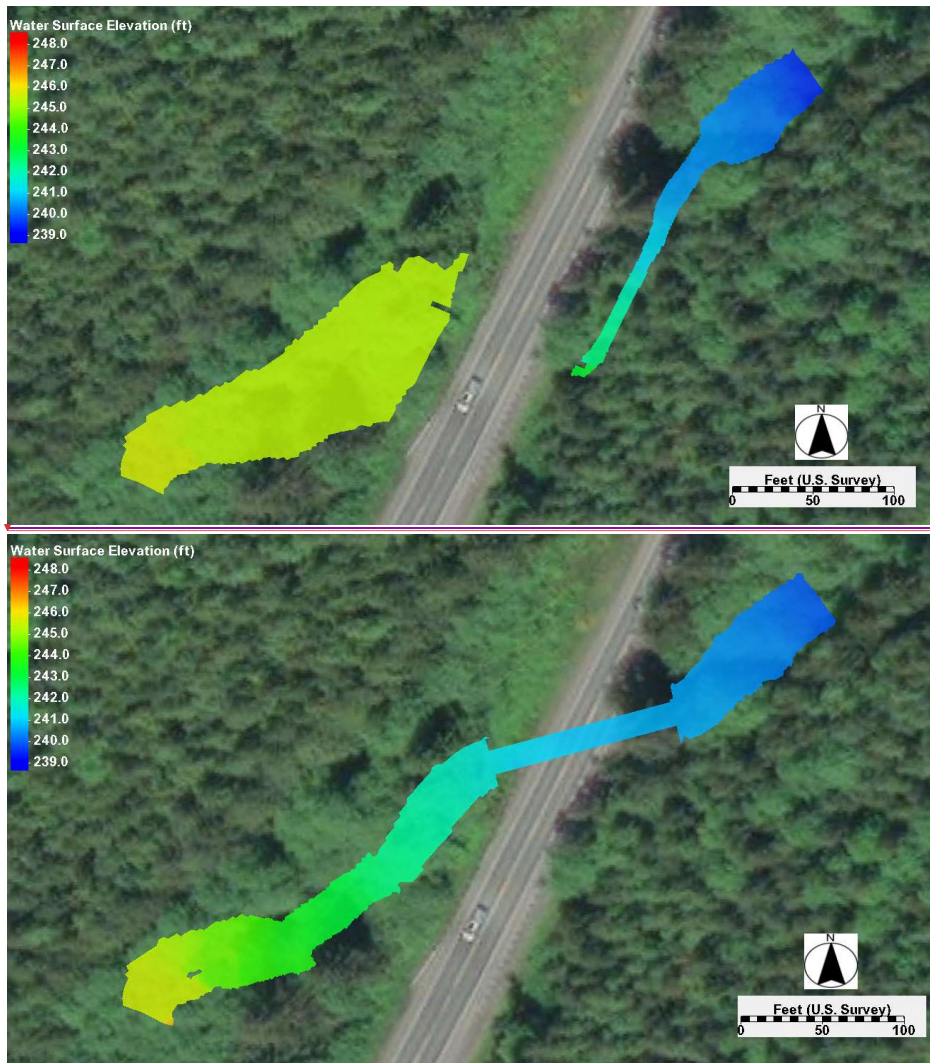
Figure 59: Water surface elevation change from existing (top) to proposed (bottom) conditions

Downstream of the outlet, the water surface elevation change varies between no change and less than a 0.1-foot rise from the existing to proposed conditions.
